DEPARTMENT OF TRANSPORTATION

Contract #: 04-0120F4Cty: SF/ALA Rte: 80 PM: 13.2/13.9File #: 1.28**WELDING INSPECTION REPORT****Resident Engineer:**Pursell, Gary**Address:** 333 Burma Road**City:** Oakland, CA 94607**Report No:** WIR-011836**Date Inspected:** 01-Feb-2010**Project Name:** SAS Superstructure**OSM Arrival Time:** 700**Prime Contractor:** American Bridge/Fluor Enterprises, a JV**OSM Departure Time:** 1700**Contractor:** American Bridge/Fluor Enterprises, a JV**Location:** Jobsite**CWI Name:** Jim Bowers**CWI Present:** Yes No**Inspected CWI report:** Yes No N/A**Rod Oven in Use:** Yes No N/A**Electrode to specification:** Yes No N/A**Weld Procedures Followed:** Yes No N/A**Qualified Welders:** Yes No N/A**Verified Joint Fit-up:** Yes No N/A**Approved Drawings:** Yes No N/A**Approved WPS:** Yes No N/A**Delayed / Cancelled:** Yes No N/A**Bridge No:** 34-0006**Component:** OBG Lift 1E**Summary of Items Observed:**

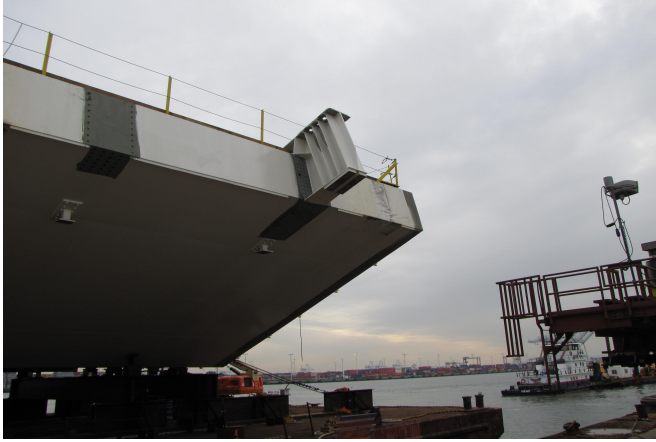
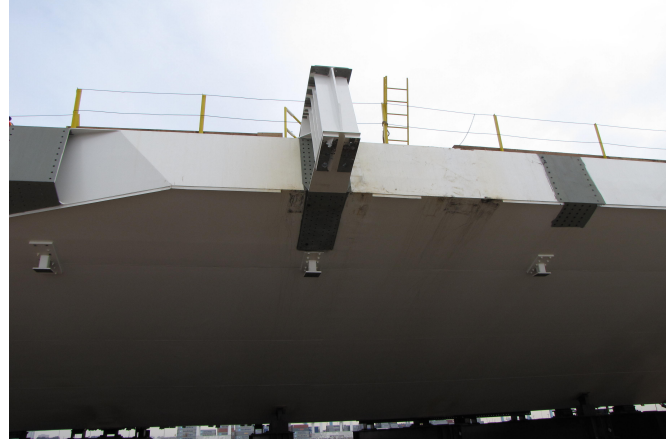
Upon arrival it was noted ABF personnel had previously placed the suspender bracket at Panel Point (PP) 10 and was in the process of placing the suspender bracket at PP12 for lift 1 East. The QA inspectors relayed to the Quality Control Manager (QCM) Jim Bowers; ABF personnel had placed these brackets prior to the completion of the arrival inspection for the South side of the OBG. The suspender bracket now covered the area in which sea fastener 2A was attached to the side of the OBG. QA inquired with Mr. Bowers why the brackets had been installed prior to QA's required Post Arrival Inspection. Mr. Bowers relayed he was unaware ABF would be placing these items as ABF had worked over the weekend. The QA inspectors proceeded with the balance of the arrival inspection at the sea fastener locations with access to the higher locations being accomplished through the use of a man lift. Access to PP12.5 was not possible at this time due to ABF personnel being in an adjacent man lift attempting to install a shim plate at this location. During this time the QA inspector noted the contractor was experiencing difficulty attempting to install the shim between the side plate and the suspender bracket at PP12 and were utilizing a sledge hammer and spud wrenches. The QA inspector observed what appeared to be a white substance similar to silicone or lithium grease on the edges of the shim plate. The QA inspector inquired from the QCM if this was the case and the QCM relayed he was not aware of any such condition. QA personnel were not able to access this specific area throughout the day due the in process worked being performed by ABF personnel.

QA had a conversation with ABF Welding Quality Control Manager, Jim Bowers inquiring about the substance that was being applied to the edge of the shim plates. Mr. Bowers informed QA that he was not sure why the substance was being applied but informed QA that he would check with the QCM, Chuck Kanapicki about the installation of the shim plates.
